UNITED STATES DEPARTMENT OF THE INTERIOR
NATIONAL PARK SERVICENATIONAL REGISTER OF HISTORIC PLACES
INVENTORY -- NOMINATION FORM

The Cloisters

The Parker Estate

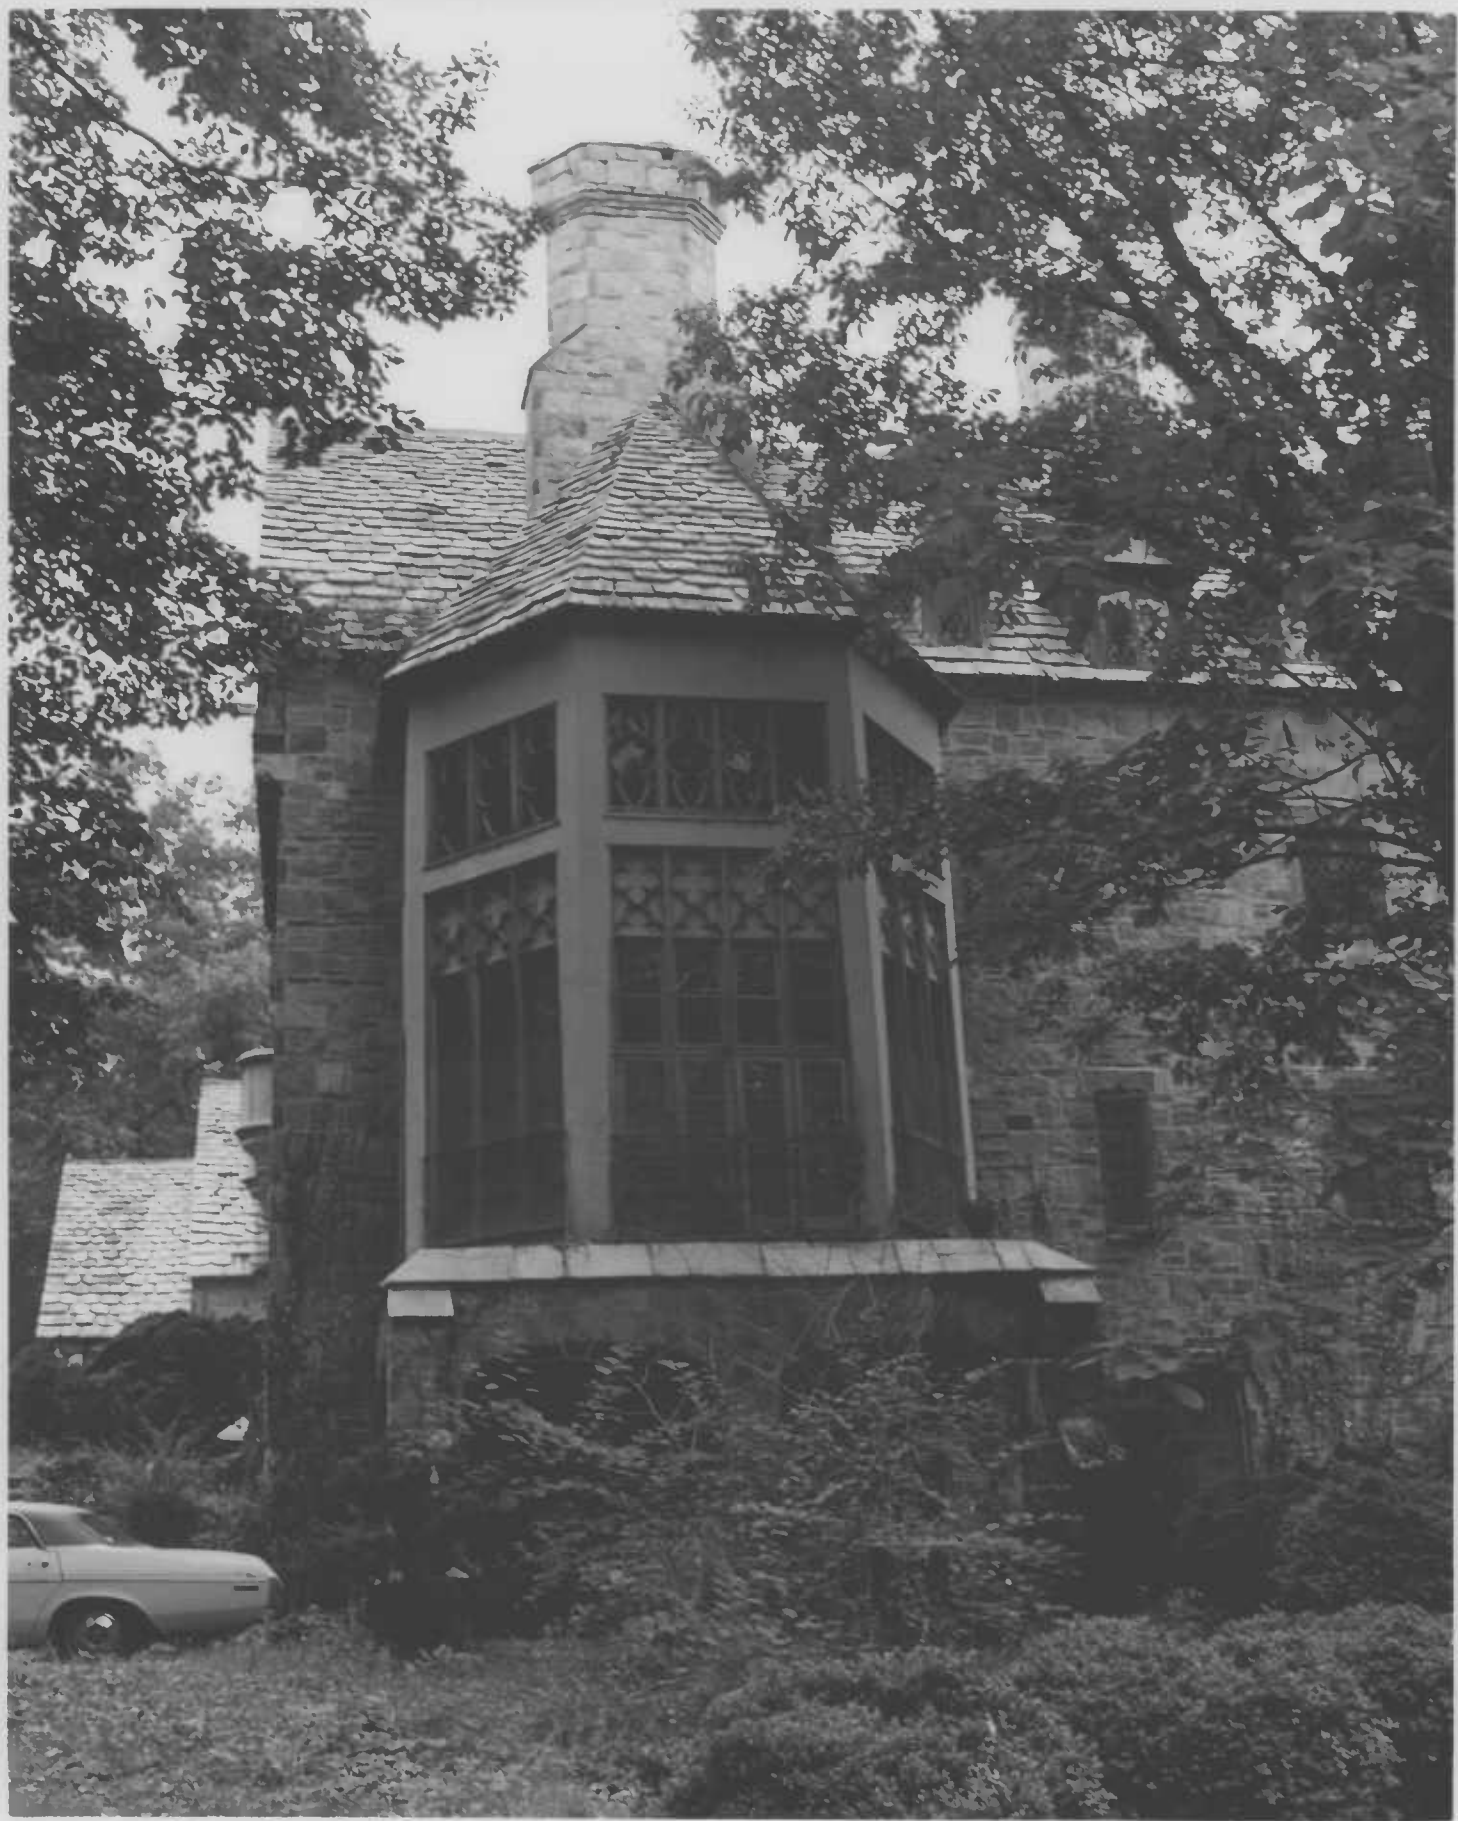
(11)

East Facade - GlenEllen porch

The east facade is the most plain, and appears the most massive, with the main block rising to a height of four stories from the basement level. The pitched roof is broken at left by one large, hexagonal chimney with a heavy molded cap. To the right of the chimney, three small adjoining dormer windows are decorated with elaborate Gothic wooden pediments. The principal feature of the east facade is a very large, hexagonal porch with pointed stone roof which rises two and one-half stories above the open carport on which it rests. The tall windows have narrow vertical sections filled with wooden Gothic tracery from the renowned Baltimore Gothic Revival mansion, Glen Ellen, designed by A. J. Davis. To the right beyond the massive central section of the east facade is a large, single story garage with two wide, wooden doors. Stone steps with a wrought iron railing lead up from the left of the garage to a battlemented terrace on top of it.

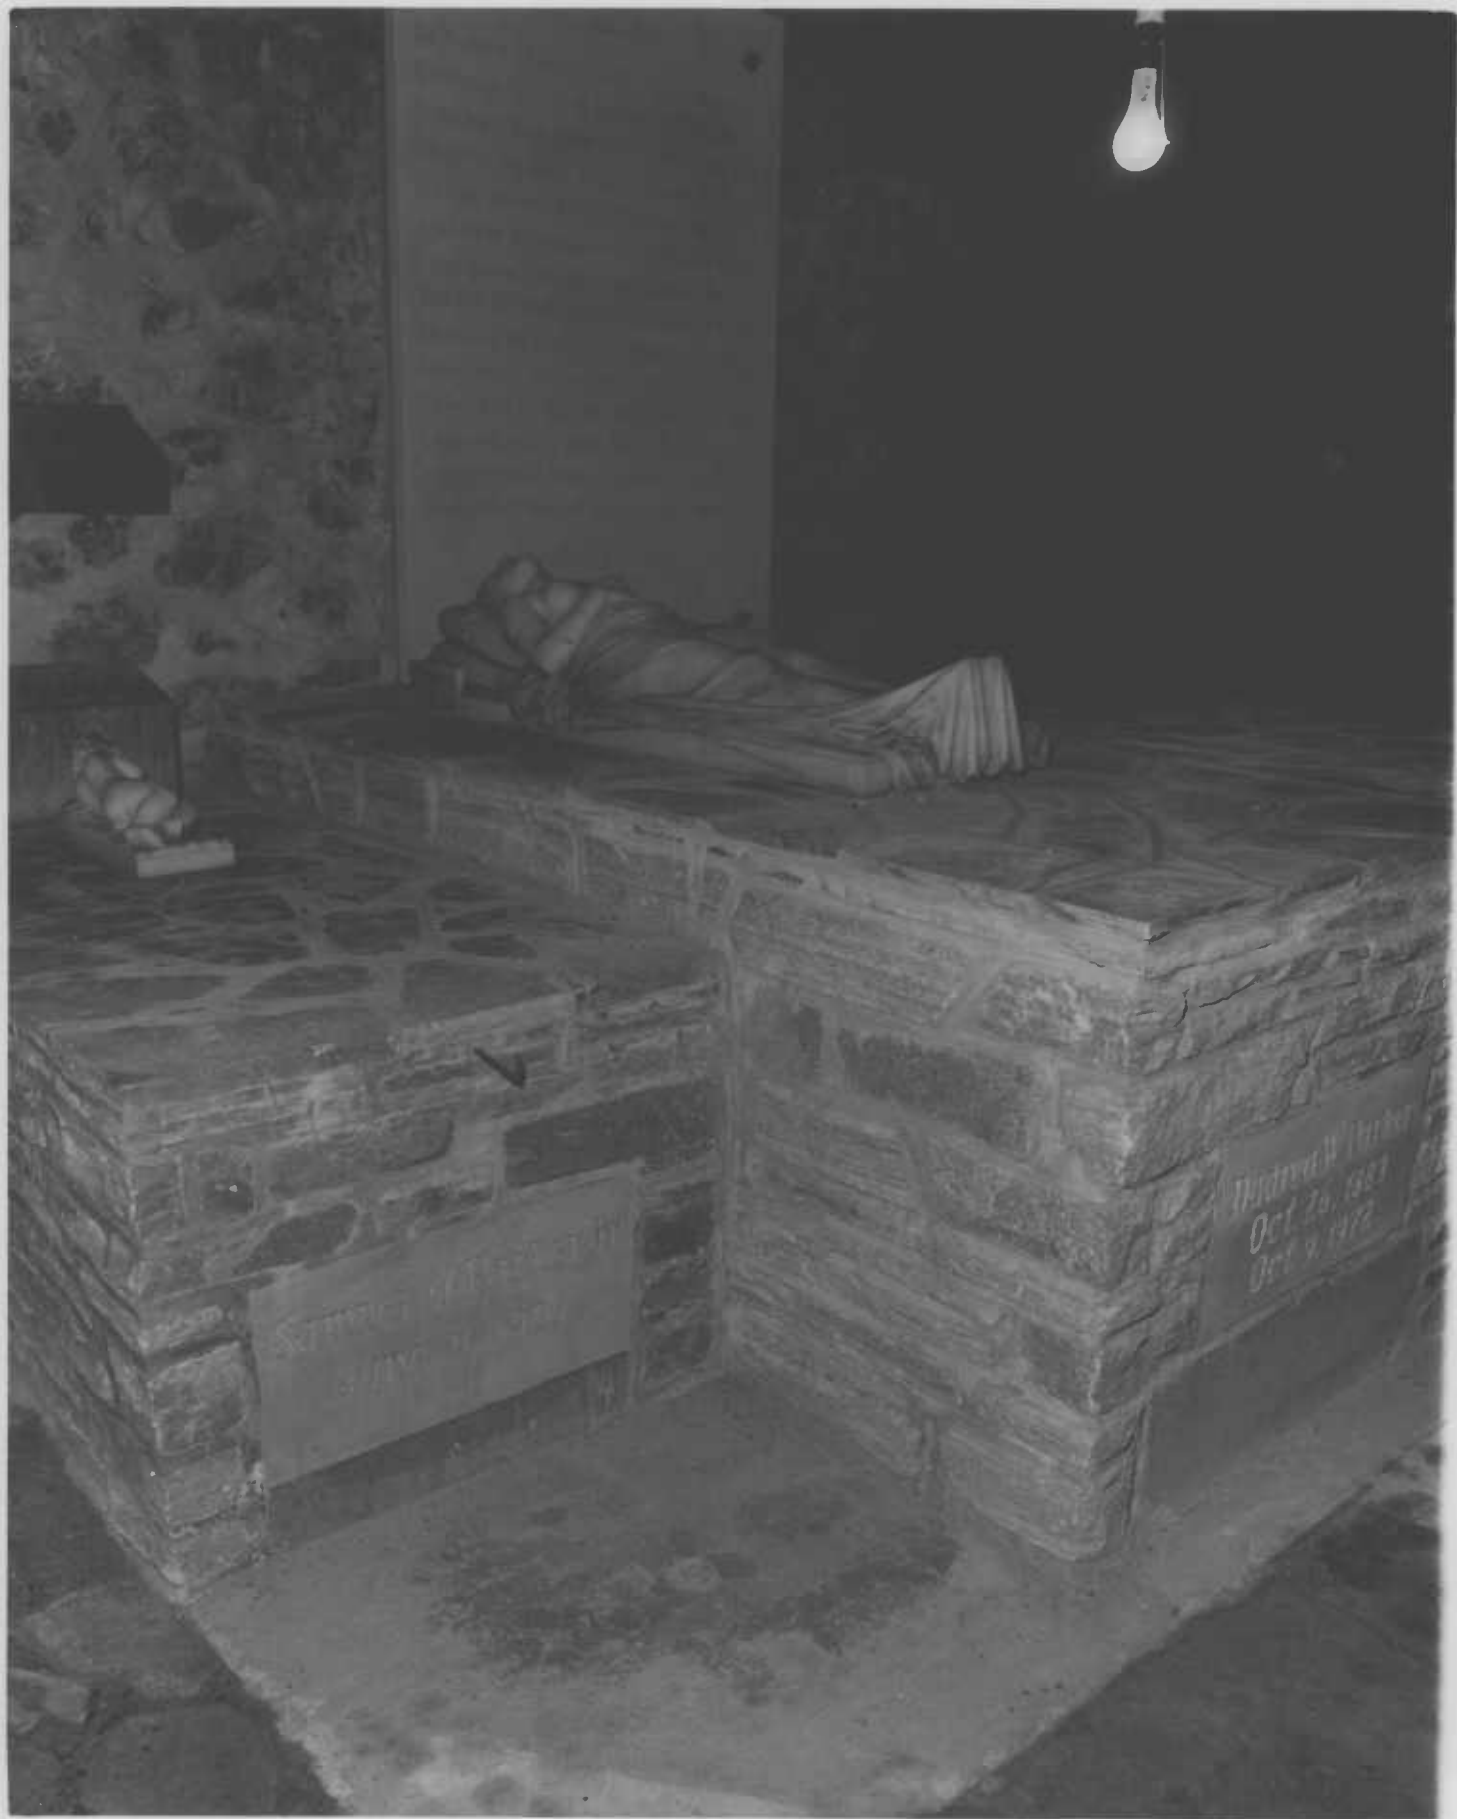
13

Interior of Crypt

Beneath the level of the basement is the large family crypt, where Mr. and Mrs. Parker and an infant son are buried under massive stone sarcophagi. The tall, octagonal, stone stair tower rises from the basement level to above the main roofline, where one is afforded a magnificent view of the surrounding rural countryside from the crenellated parapet.

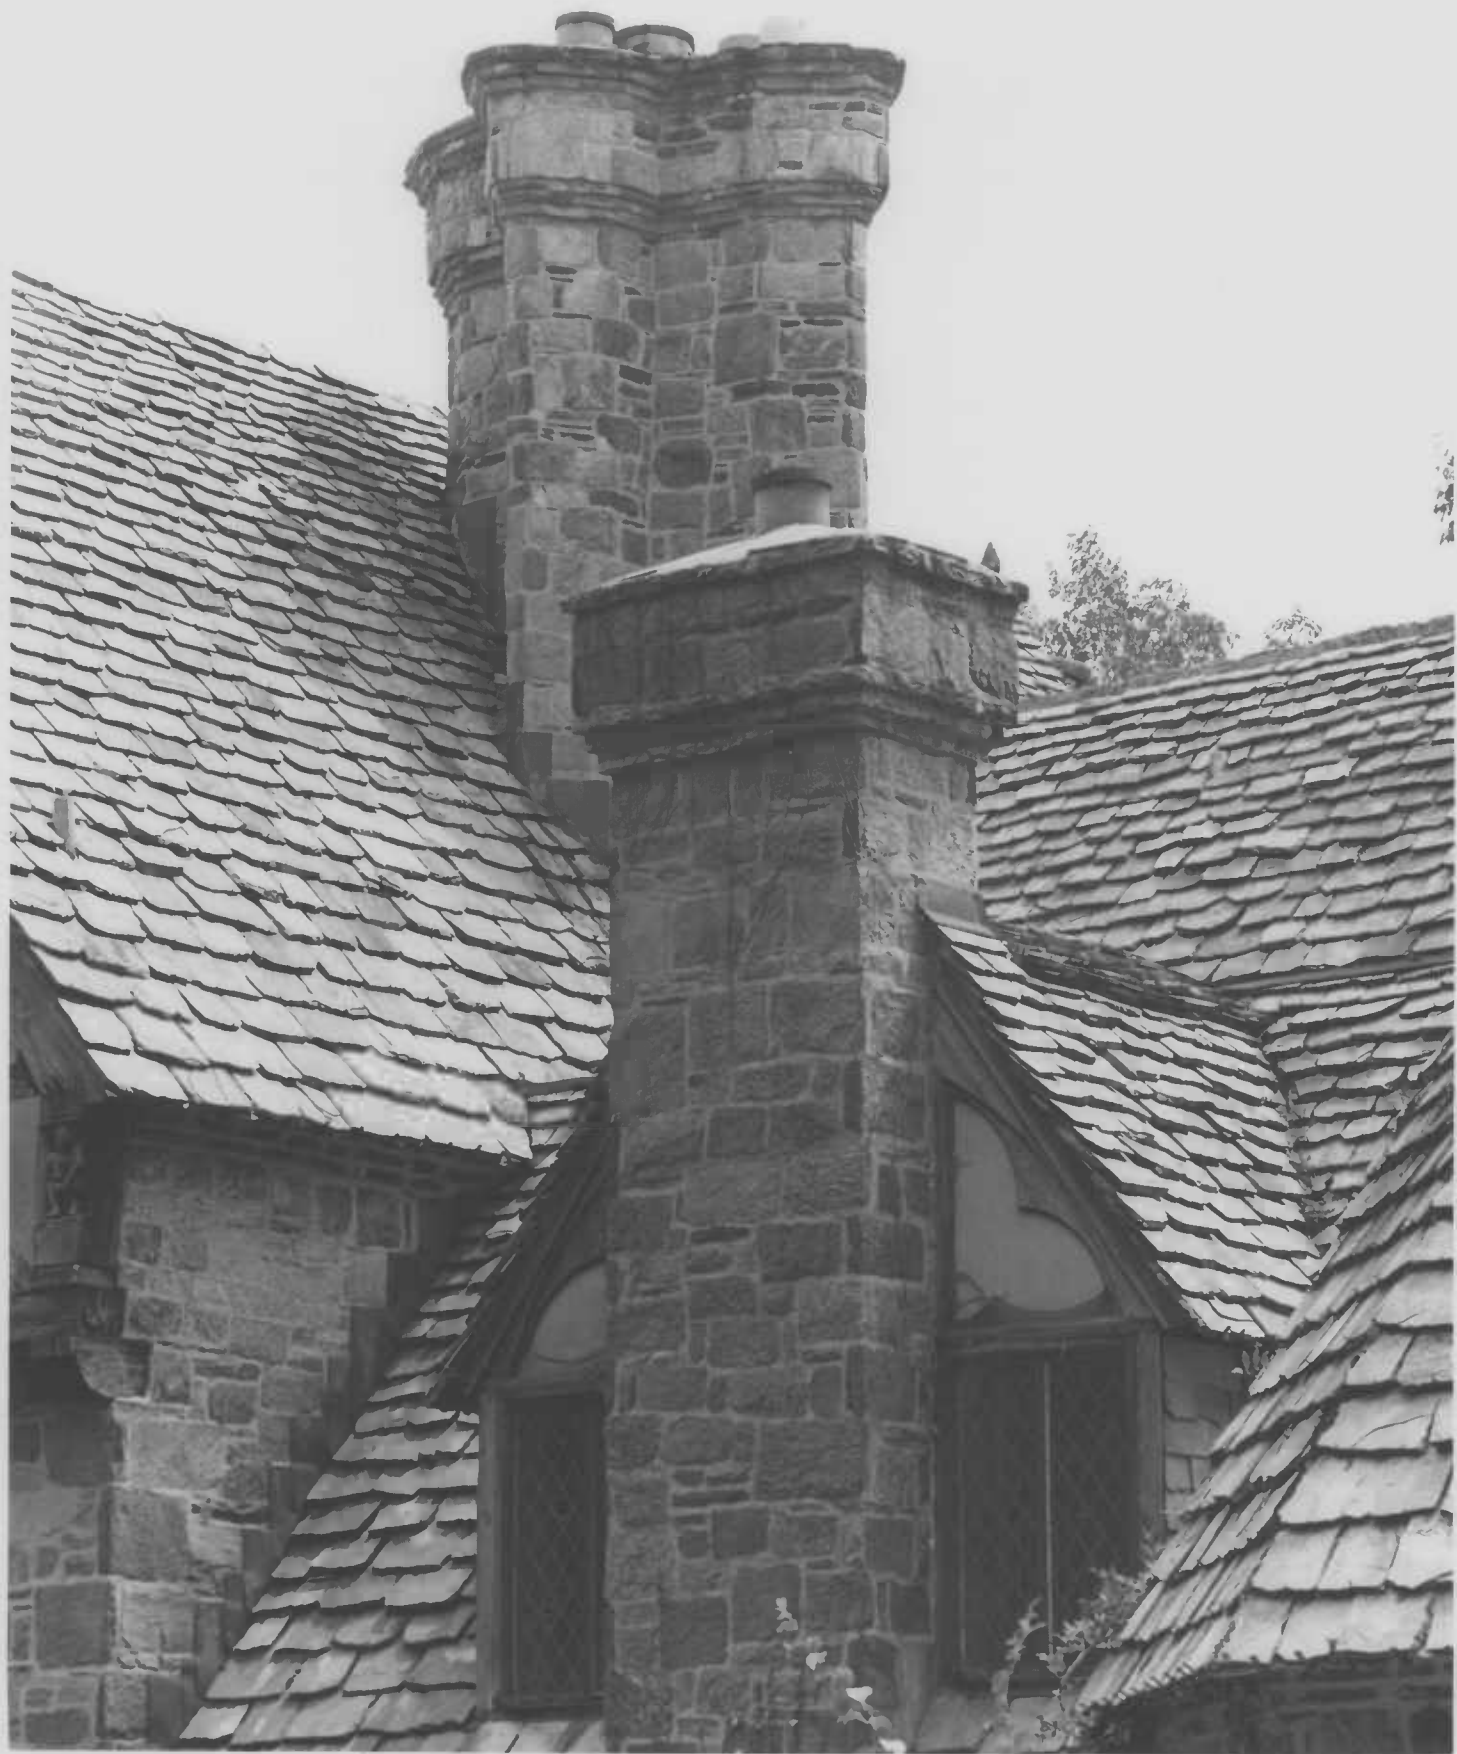
The Cloisters (9)

North Facade - Detail

The rear (north) facade of The Cloisters is perhaps the most interesting architecturally with its picturesque interplay of unusual forms and materials. A large courtyard is enclosed by the cloister which slopes gently down the hillside to a length of nine bays. The rear facade is dominated by the two gable-ended sections with half-timbered top stories off center to the left in the facade. A handsome and massive chimney of quatrefoil shape rises from the center of the right slope of the roof at the right gable. Between the two sections rises the striking form of a massive stone octagonal stair tower. The tower is lighted by narrow windows which climb the sides in diagonal lines. It is crowned by a crenellated parapet and a small, round, stone-roofed structure from which one can exit onto the roof of the main tower. To the right of the right-hand gabled section is a one and one-half story section whose sloping roof is broken by a large, gabled dormer window. Rising through the center of this dormer is a rectangular chimney with a large, blocklike cap with stepped lower edge.

Other important decorative features of the north facade include a handsome single story, three-sided porch which stands on the right side of the right half-timbered gable section. This porch, which forms the main entrance from the house to the cloister-enclosed terrace, is decorated with wooden Gothic-style tracery, particularly a frieze of quatrefoils beneath the roof. To the right, beneath the rectangular chimney, is a fine 17th century french marble fountain with a tall back and projecting triangular pediment.

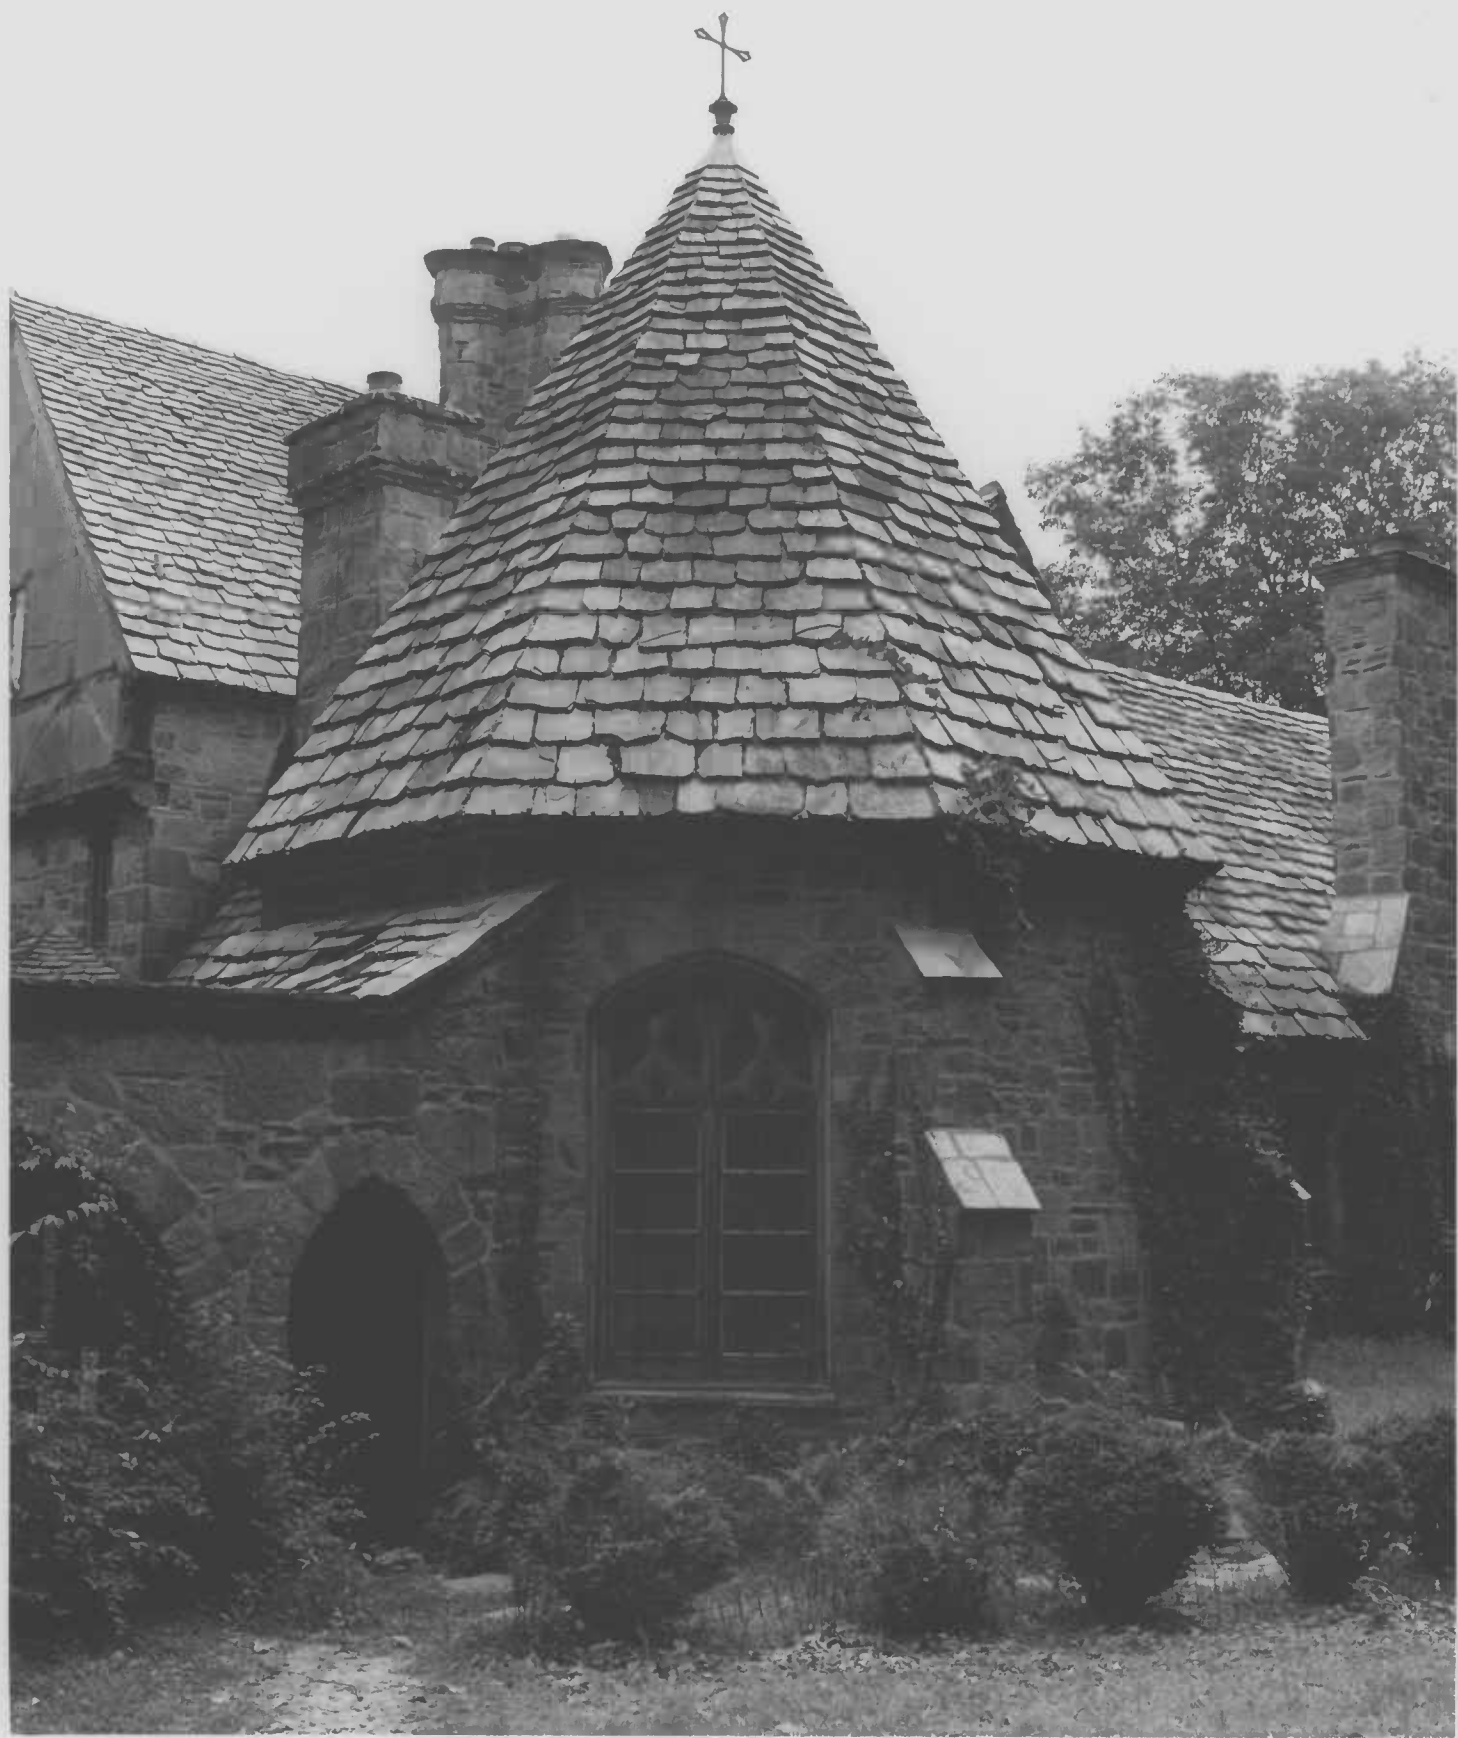
Detail - Chapel from NW side

Projecting outwards from the left side of the wing is an octagonal chapel with a tall, sloping roof whose apex is topped by an iron cross. Small buttresses project at the three corners. Two sides of the chapel are lighted by full length windows. From the left side of the chapel extends the stone and wood cloister area. The single story, flat-roofed cloister has four Gothic-arched openings and a low, arched doorway on this west facade. The wooden interior frame of the cloister may have originated in France.

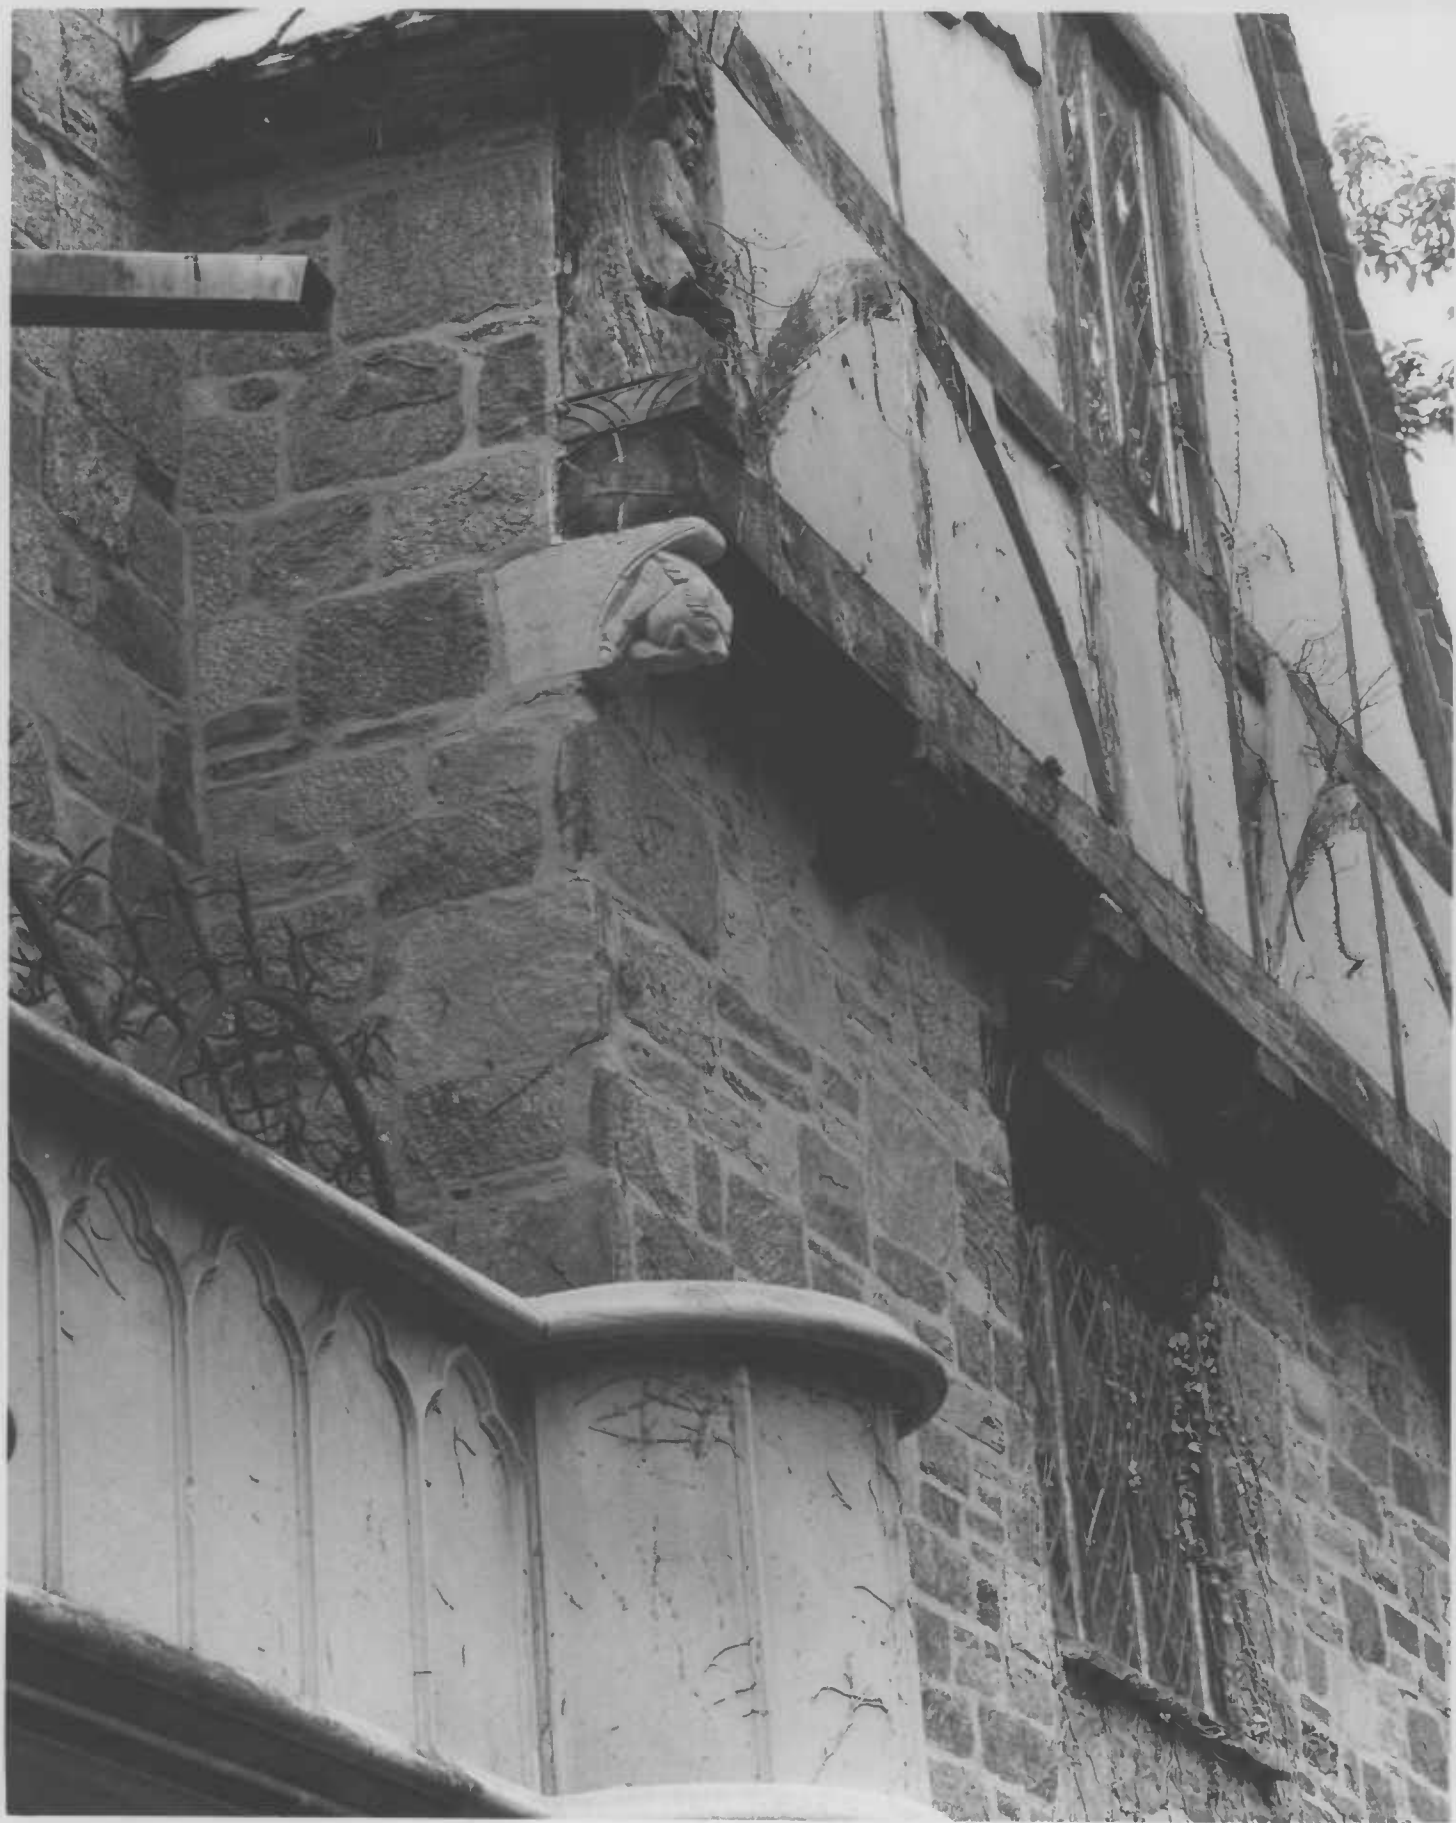
The Cloisters (5)
Balto. Co.

South Facade - Detail
Right Gable and Balcony

The main (south) facade is dominated by two assymetrically placed, projecting sections topped by massive half-timbered gables which were originally part of a Medieval house in Domremy, France. Both sections are two bays wide but the one on the left is broader than the right. Between these sections is a recessed bay which is crenelated at the top. Across this bay a grey stone balcony with turreted ends connects the two projecting sections; below the balcony is the front door. On the far left side of the main facade is a projecting wing, two stories high with gable end facing south. The front of this wing is covered with a plaster and wood, arched, half-timbered design accented on the posts and studs by small carved gargoyle-like figures.

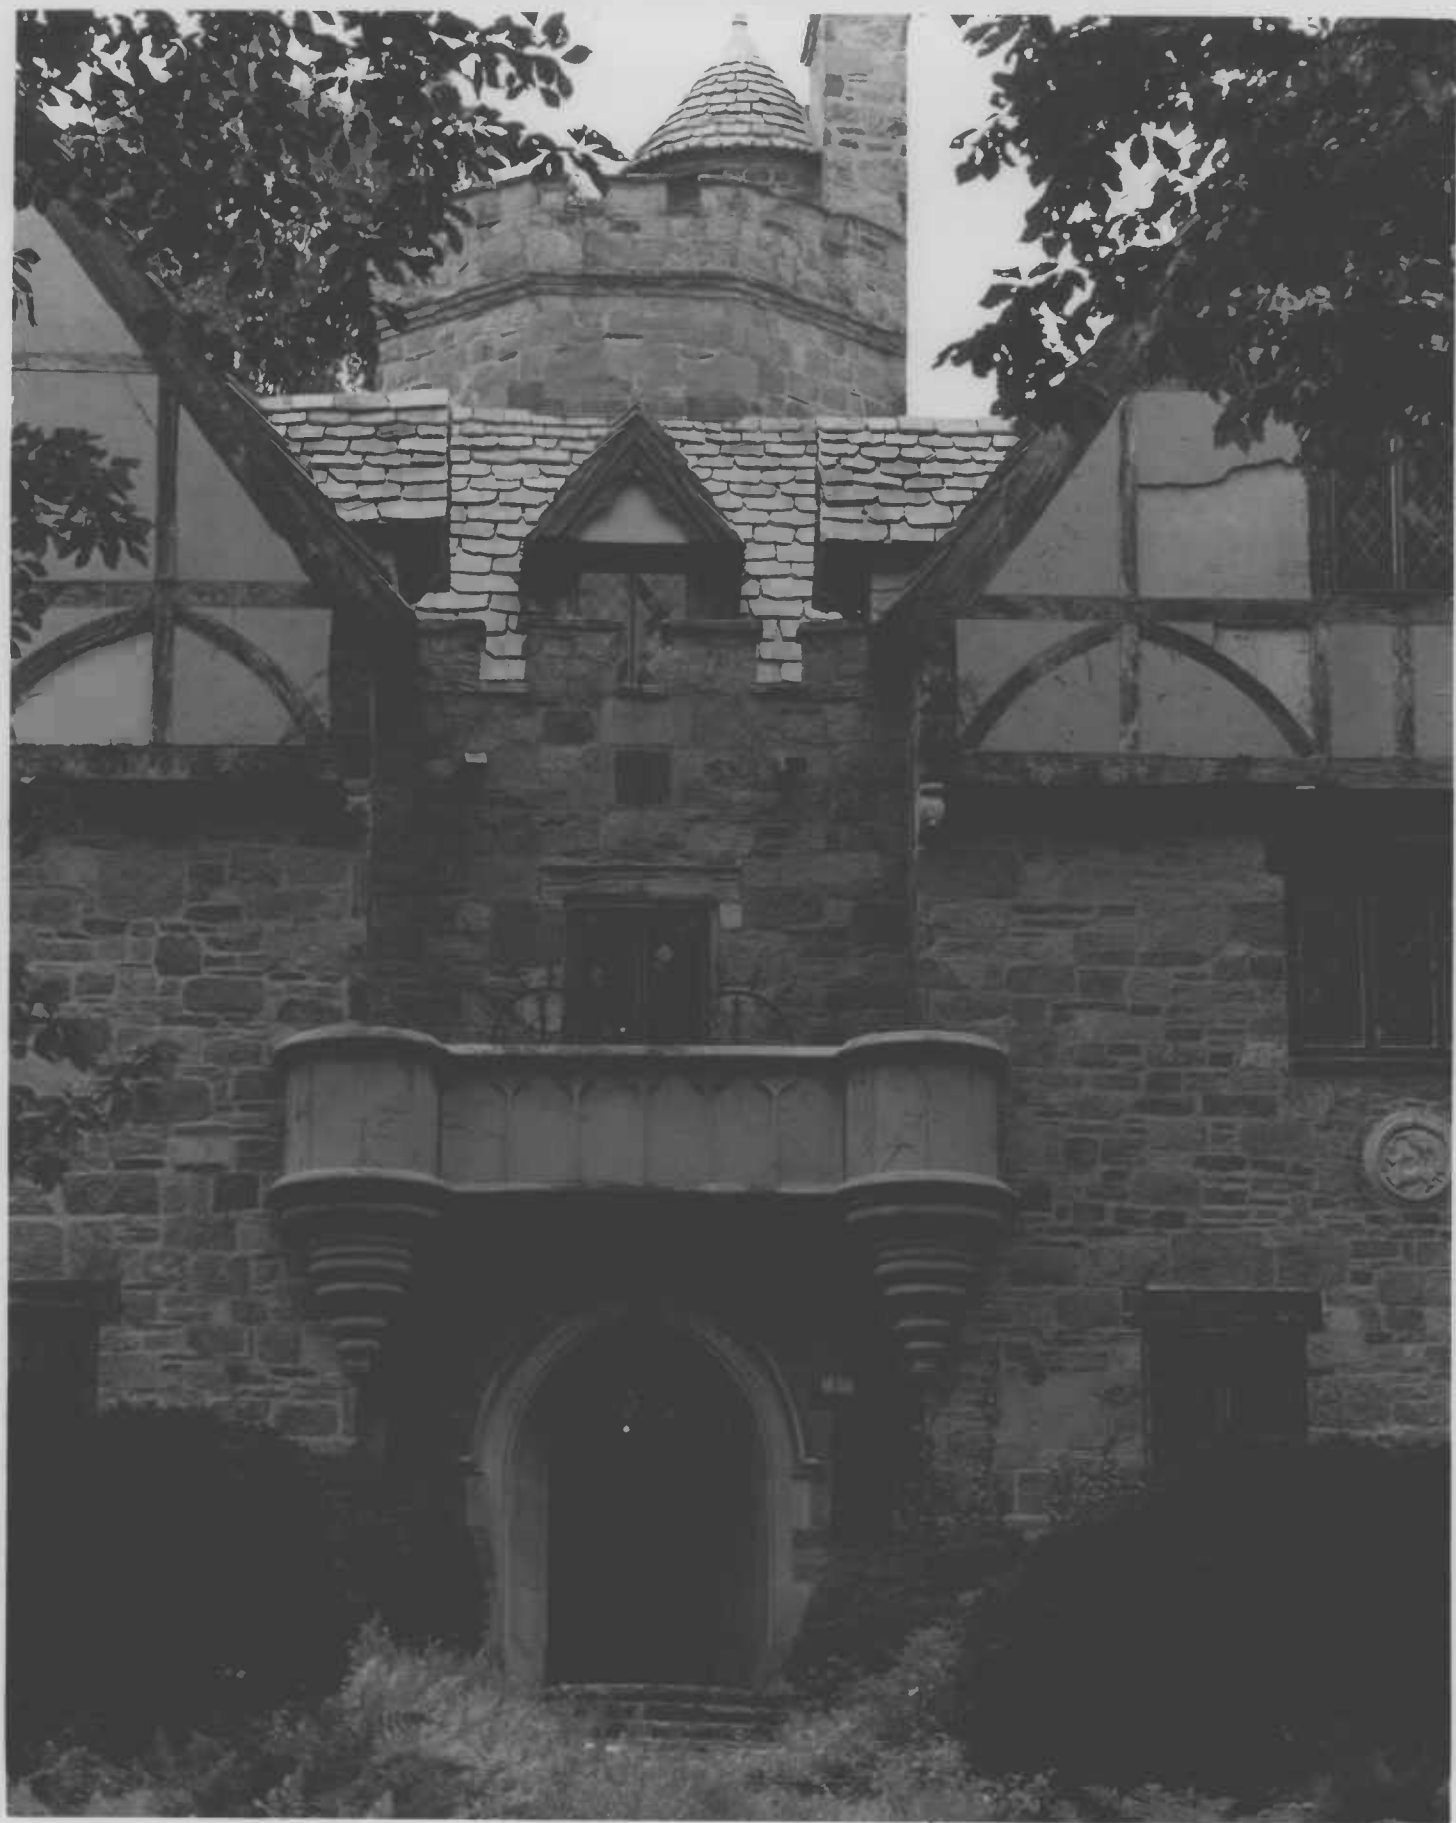
②

South facade (Detail)

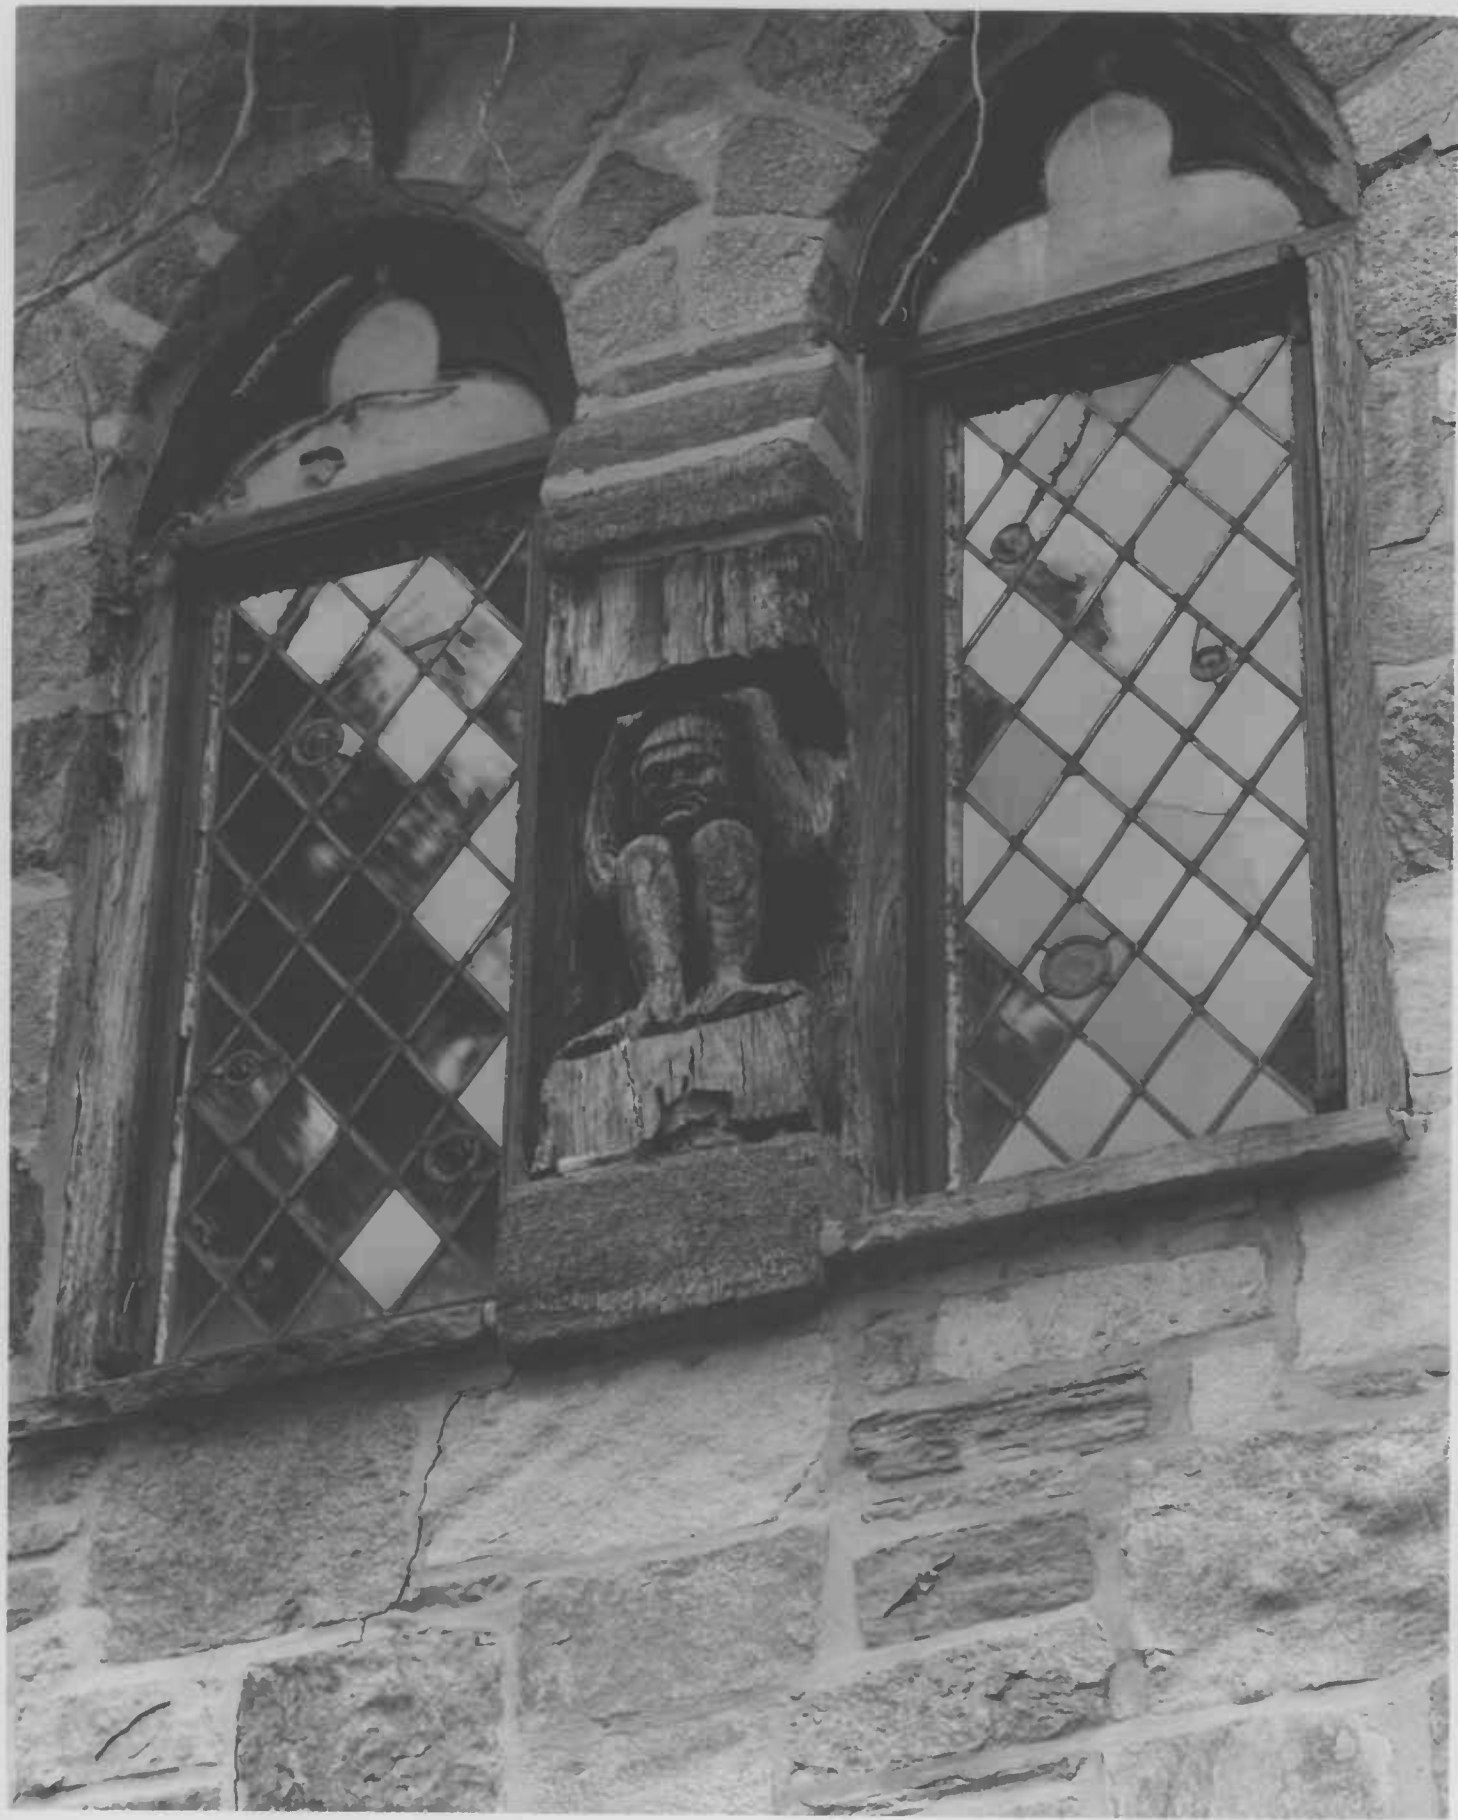
(4)

South Facade - Detail
Second floor window

The windows of all the facades are diamond-paned, iron casement windows with random circular bits of stained glass. The windows vary in dimension, most being composed of one, two or three narrow, vertical sections, and are irregularly spaced along the facade. Most windows have flat stone sills and heavy wooden lintels with flat upper edges and curved lower edges. One unusual window in the main facade is the pair of narrow, Gothic arch-shaped windows on the second floor in the recessed bay to the left of the left-hand projecting gabled section. The rectangular windows are surmounted with carved wooden, trefoil-shaped motifs and separated by a small, carved wood, gargoyle-like figure.

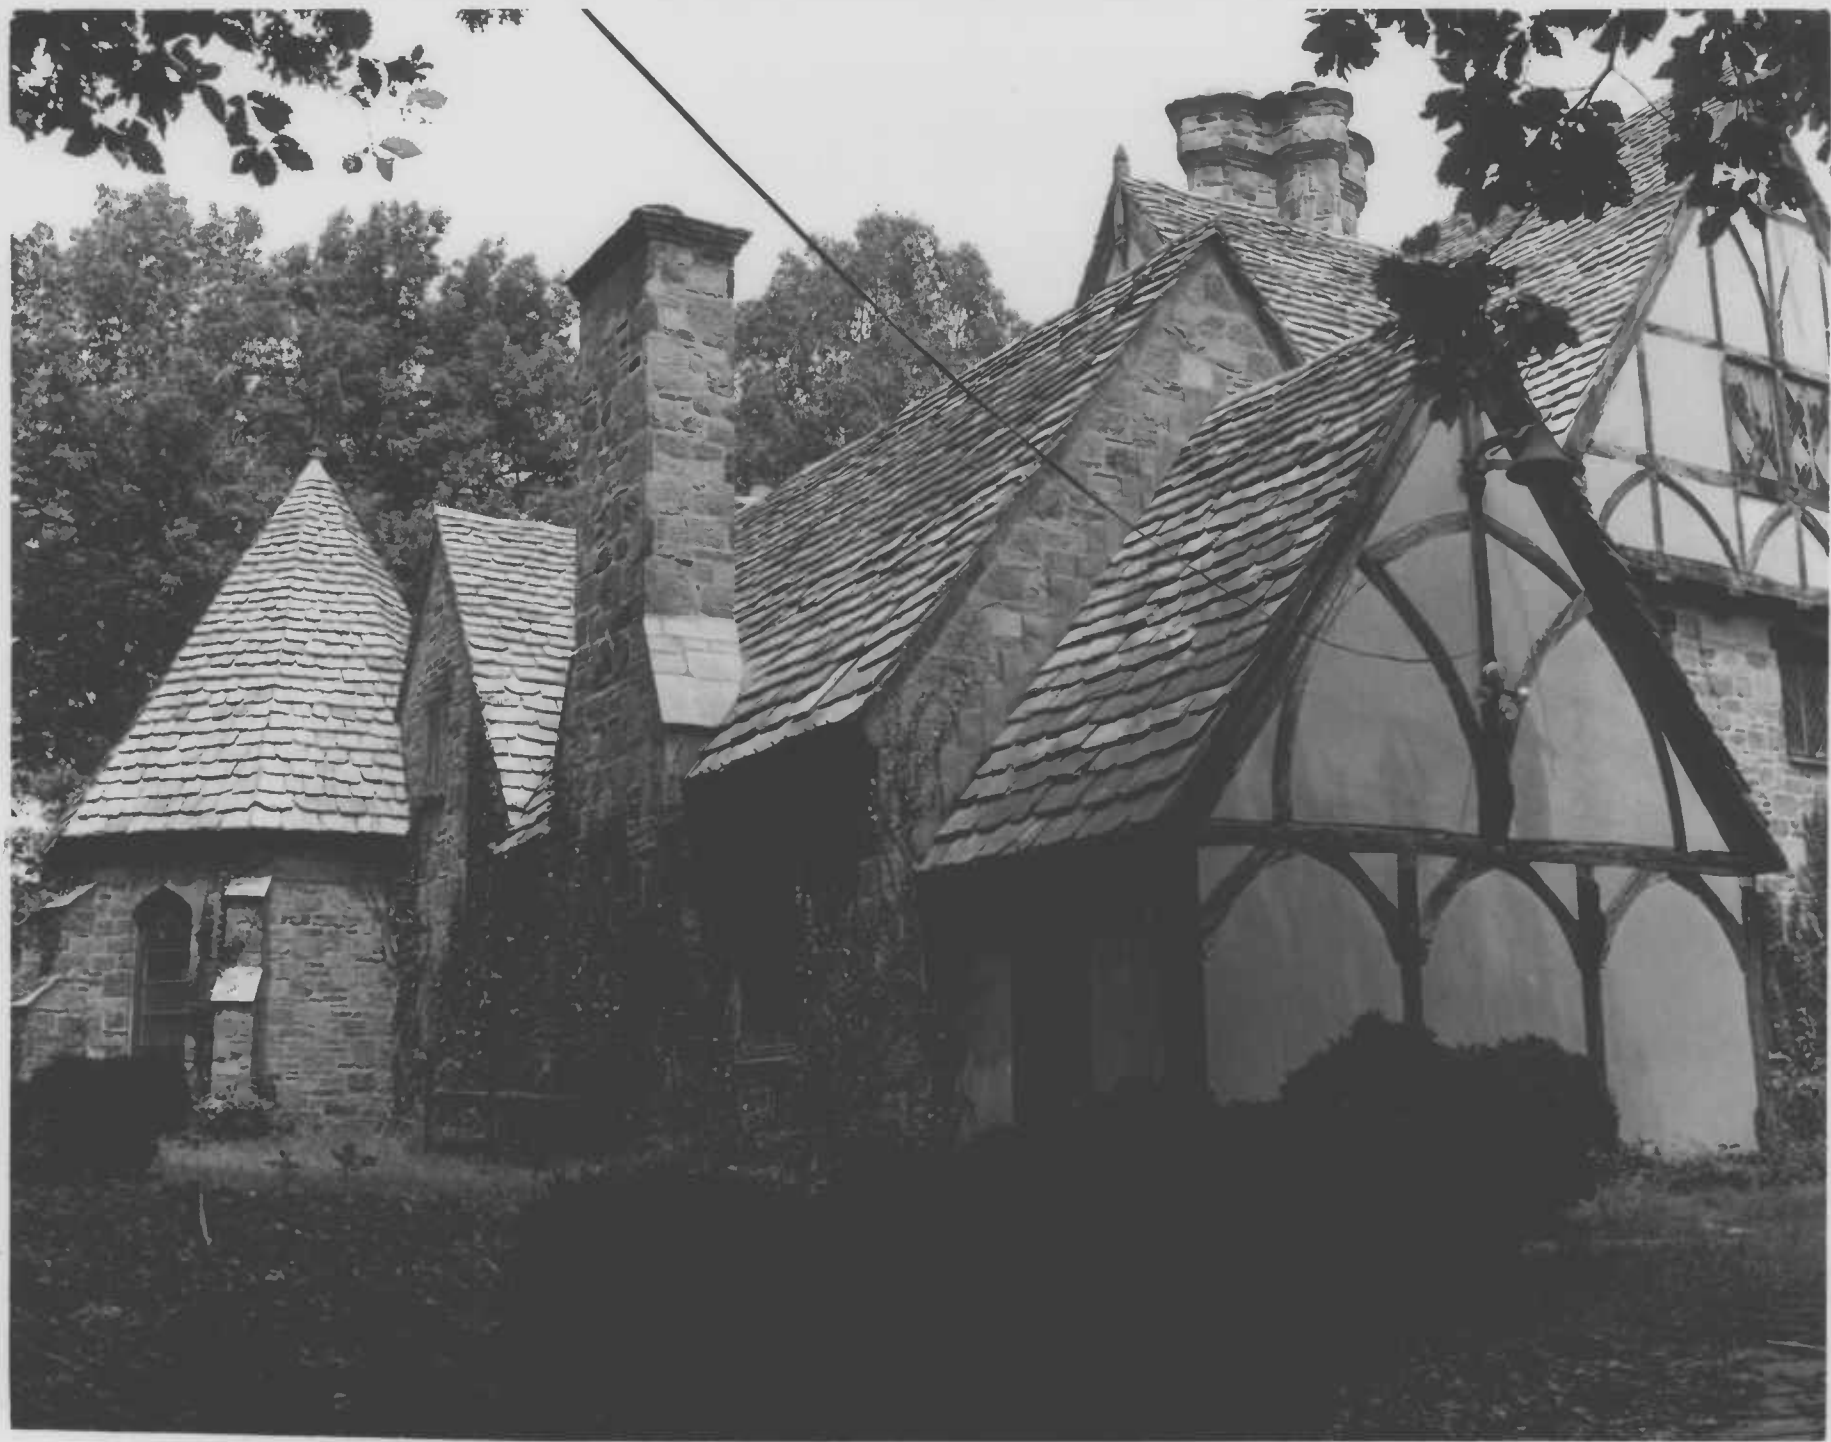
BA-1186 (6)

South west Corner showing West Facade

Moving clockwise to the west facade, the house viewed closely from this side appears to be only one and one-half stories in height. As one moves farther back from the west facade, the jagged forms of roof-lines, chimneys and towers of the central sections begin to appear above the lower roof line. The high-pitched roof on the right side of this wing is broken by a tall, rectangular, projecting, stone chimney with a stepped cap and is terminated on the left by a broad gable with a central window. The chimney, which is additionally decorated by a small, round, antique white, stone medallion, has two windows on either side of it on the first floor.
